Live Load Deflection Performance of Glued Laminated Timber Girder Bridges

Travis Hosteng, Brent Phares, Terry Wipf, Mike Ritter, and Doug Wood

Transportation Research Record: Journal of the Transportation Research Board, No. 1928, Transportation Research Board of the National Academies, Washington, D.C., 2005, pp. 174–182.

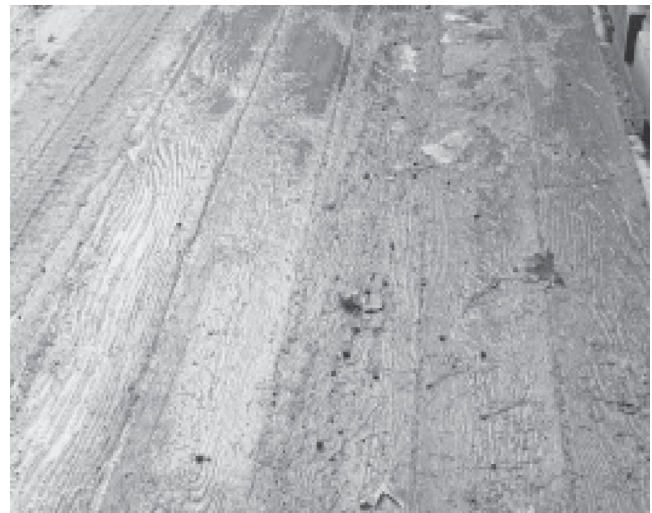
The Badger Creek Bridge (1) spans 31 ft and consists of four glued laminated girders, a transverse glued laminated deck lag screwed to the girders, and a longitudinal timber plank wearing surface (see Figure 2). The bridge showed no signs of wearing-surface deterioration, deflection-induced or otherwise, in the longitudinal plank wearing surface or structural components. The panel joints on this bridge were difficult to locate, and no signs of moisture ingress between the panels were evident; this suggested that there was a tight fit between the deck panels. Similarly, the panels appeared to be well seated on the girders with no visible gaps.

Maximum midspan girder deflections were less than approximately -0.30 in. Panel deflections relative to the girders and maximum differential panel deflections were well within the 0.10 -in. limit. (Differential panel deflections were typically less than 0.015 in.) These relatively small differential panel deflections possibly were affected by the longitudinal plank wearing surface, which may reduce differential deflections by distributing load longitudinally from panel to panel. Because of the lack of deterioration in the plank wearing surface, the differential panel deflections and live load deflection behavior of the bridge in general did not appear to be affecting the condition of the wearing surface on the bridge.

FIGURE 2 Longitudinal plank wearing surfaces on Oregon bridges: (a) Badger Creek Bridge wearing surface (2002) and (b) Camp Creek Bridge, deteriorating longitudinal plank wearing surface (2002).

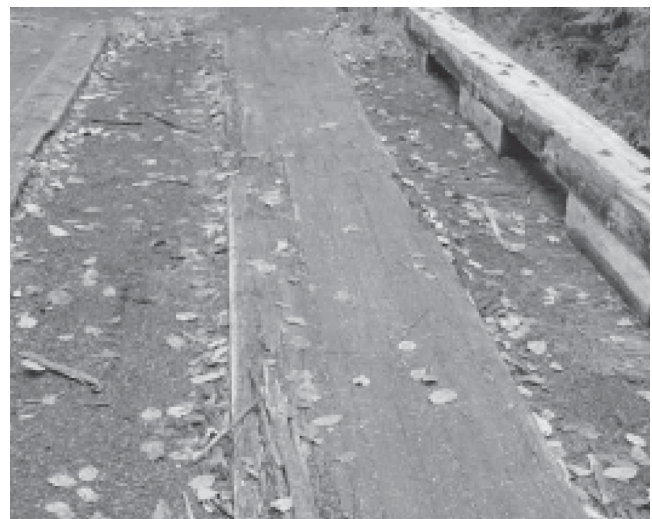
(b)

Signs of deterioration were evident in both the longitudinal plank and the asphalt wearing surfaces on this bridge but likely cannot be directly attributed to live load deflections. Rather, the deterioration appears to be from the weather and traffic wear, which were possibly compounded by live load deflections. The basis for this conclusion is that deterioration of the longitudinal planks was evident only in the

two lines of planks on the outside and inside of each respective wheel line. As with the longitudinal planks, the deterioration of the asphalt is not believed to be the result of load-induced deflections but is caused mainly by the detachment of the asphalt from the deck panels and wear from traffic and weather. In addition, accumulation of debris on the deck possibly trapped moisture, resulting in the accelerated deterioration of the deck panels and wearing surfaces.

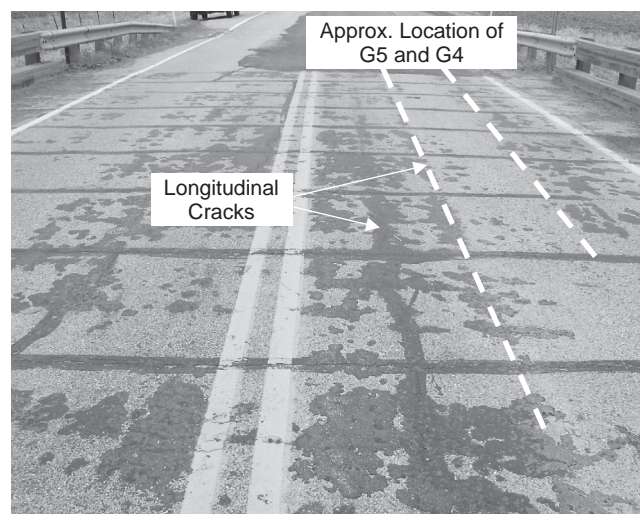
The maximum girder deflection and maximum differential panel deflection were -0.85 in. and 0.03 in., respectively. The maximum deflection (-0.85 in.) was measured at Girder G4 in both test cases. Deflection of Girder G5 was approximately -0.40 in. Additionally, inspection of the wearing surface found longitudinal cracks in the asphalt wearing surface above Girder G5. The large differential girder deflection between Girders G4 and G5 is believed to be one cause of the longitudinal cracking in that area (see Figure 3). In addition to the

FIGURE 3 Erfurth Bridge, wearing-surface deterioration (2003).

longitudinal cracks above Girder G5, transverse cracks located above each panel joint were evident (see Figure 3). Panel deflections relative to the girders were less than -0.08 in.

In the case of the Erfurth Bridge, the relatively thin 3.5-in. deck panels resulted in the large differential panel deflections. However, in addition to the thin deck, it is noted that large global girder deflections as well as other factors may have effected the deterioration of the wearing surface.

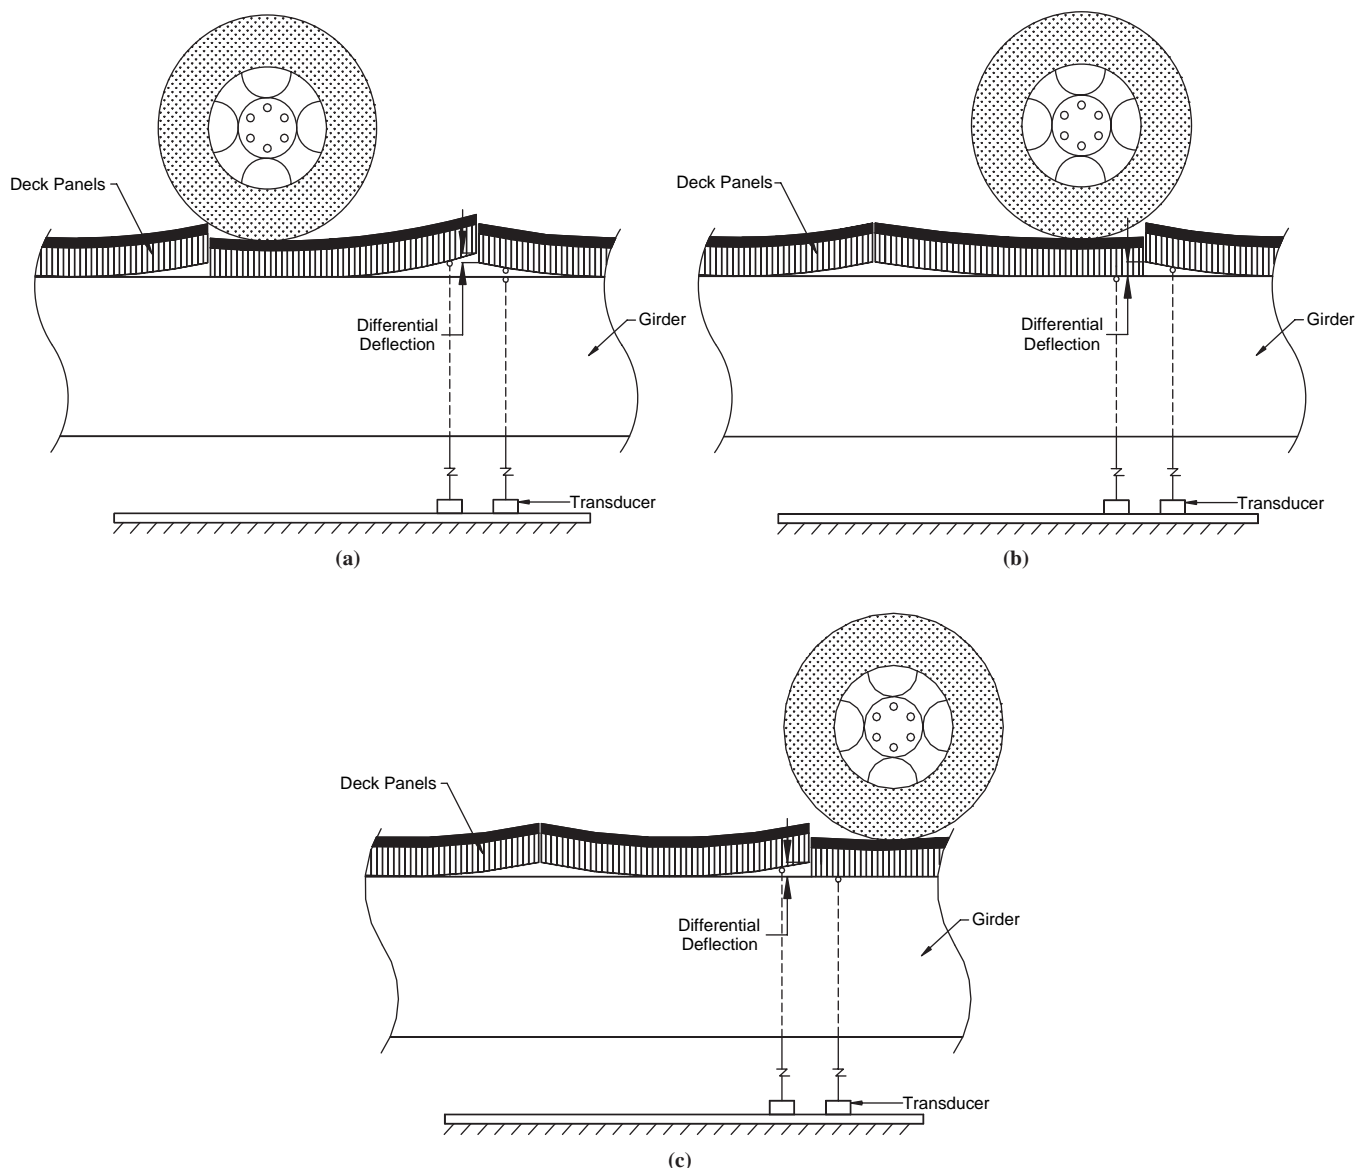
FIGURE 4 Differential panel deflection caused by cupped deck panels.

In the case of the Butler County Bridge, the differential panel deflections and significant deterioration of the asphalt were found to be caused by the cupping of the deck panels. Typically, the differential panel deflections will spike once during the passage of each load truck axle. Because of the cupping of the deck panels, the differential panel deflections spiked three times for the passage of each axle. This behavior is illustrated in Figure 4. The cupping of the deck panels resulted in multiple stress reversals in the wearing surface for each load that passes over the joint, whereas flat panels typically experience one or two stress reversals per load passage.

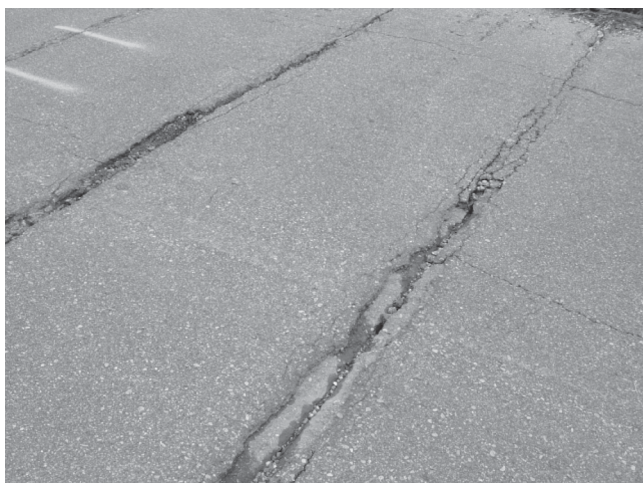
FIGURE 5 Butler County Bridge, severe wearing-surface deterioration (2003).

contributor to the cracking and disintegration of the asphalt above the panel joints shown in Figure 5.

Severe full-width transverse cracking on the Butler County Bridge was evident at each deck panel joint along the entire length of the bridge (see Figure 5). The transverse cracks were approximately 2 in. wide, and in most cases the moisture barrier between the deck and the asphalt was severed. These cracks were found to be the result of severe cupping of the deck panels, concave upward, which is believed to be the result of changes in moisture content, and may have been compounded by initially being slightly cupped before installation. The cupping of the panels has resulted in gaps between adjacent deck panels of approximately 0.50 in.

- As was clearly shown in the performance of the wearing surface of the Butler County Bridge, the condition of the deck panels (specifically, cupping of the deck panels) was a significant factor affecting the deterioration of the asphalt wearing surface.

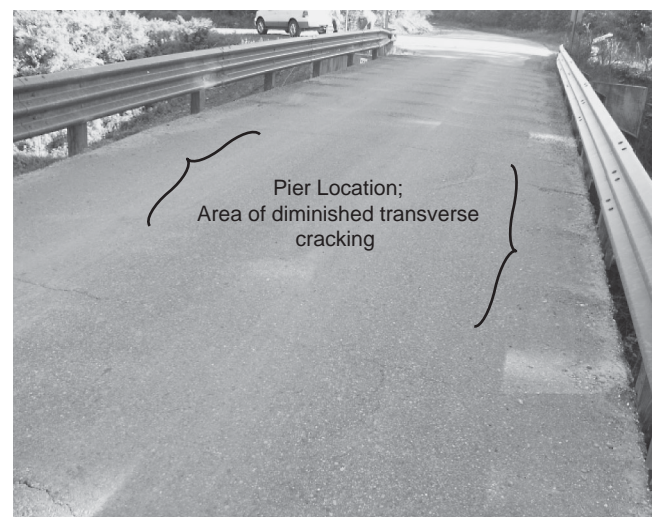
Significant stair-stepping was evident in the deflection pattern of the girders and deck panels. This behavior and the decrease in differential panel deflections from 1995 to 2003 are believed to be caused by increases in moisture content and the subsequent swelling

of the deck panels. The swelling can increase the contact surface friction between the panels. The repeated buildup and release of friction between adjacent deck panels as the load passes over the bridge is likely the source of the stair-stepping behavior.

In the case of the Wittson Bridge, despite its deflection performance satisfying code requirements, the pattern of transverse deck cracking was atypical when compared to the other bridges tested. Figure 6 illustrates the condition of the wearing surface. Transverse cracks were evident directly over the panel joints for approximately 85% of the length of each of the three shorter spans but were nonexistent 10 ft on each side of the piers (see Figure 6). In addition, minimal transverse cracking was evident over most of the long span.

FIGURE 6 Wittson Bridge, irregular pattern of wearing-surface deterioration (2003).
